# **BOWEN BROKEN BOGIE WATER QUALITY PROGRAM**

## **Achievements and learnings**

### **July 2025**

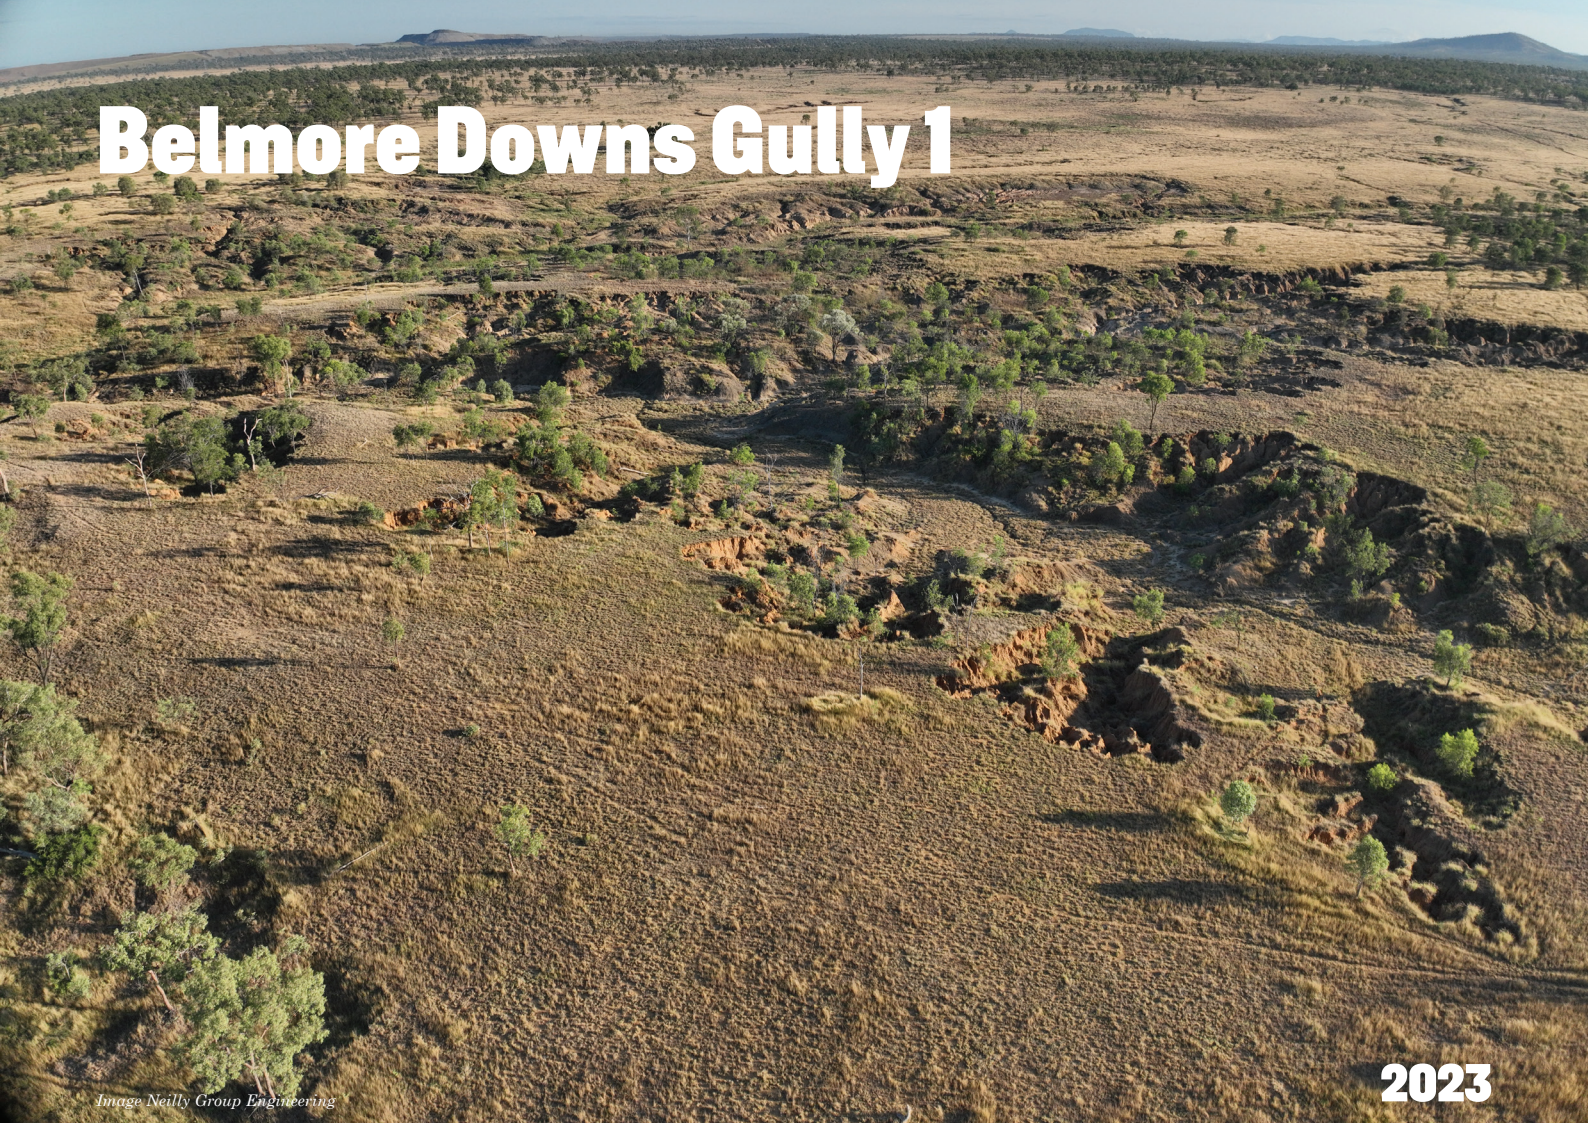
# Belmore Downs Gully 1

**2023**

Earthworks reshaped active alluvial gullies. Bunds were installed to divert the overland flow that was contributing to gully head erosion and direct flows into armored rock chutes. Porous rock check dams were installed throughout the gully network to slow

erosive flows and allow for soil deposition. Rigorous soil testing was completed to identify the deficiencies in soil chemistry that are contributing to erosion and the identify the required amelioration.

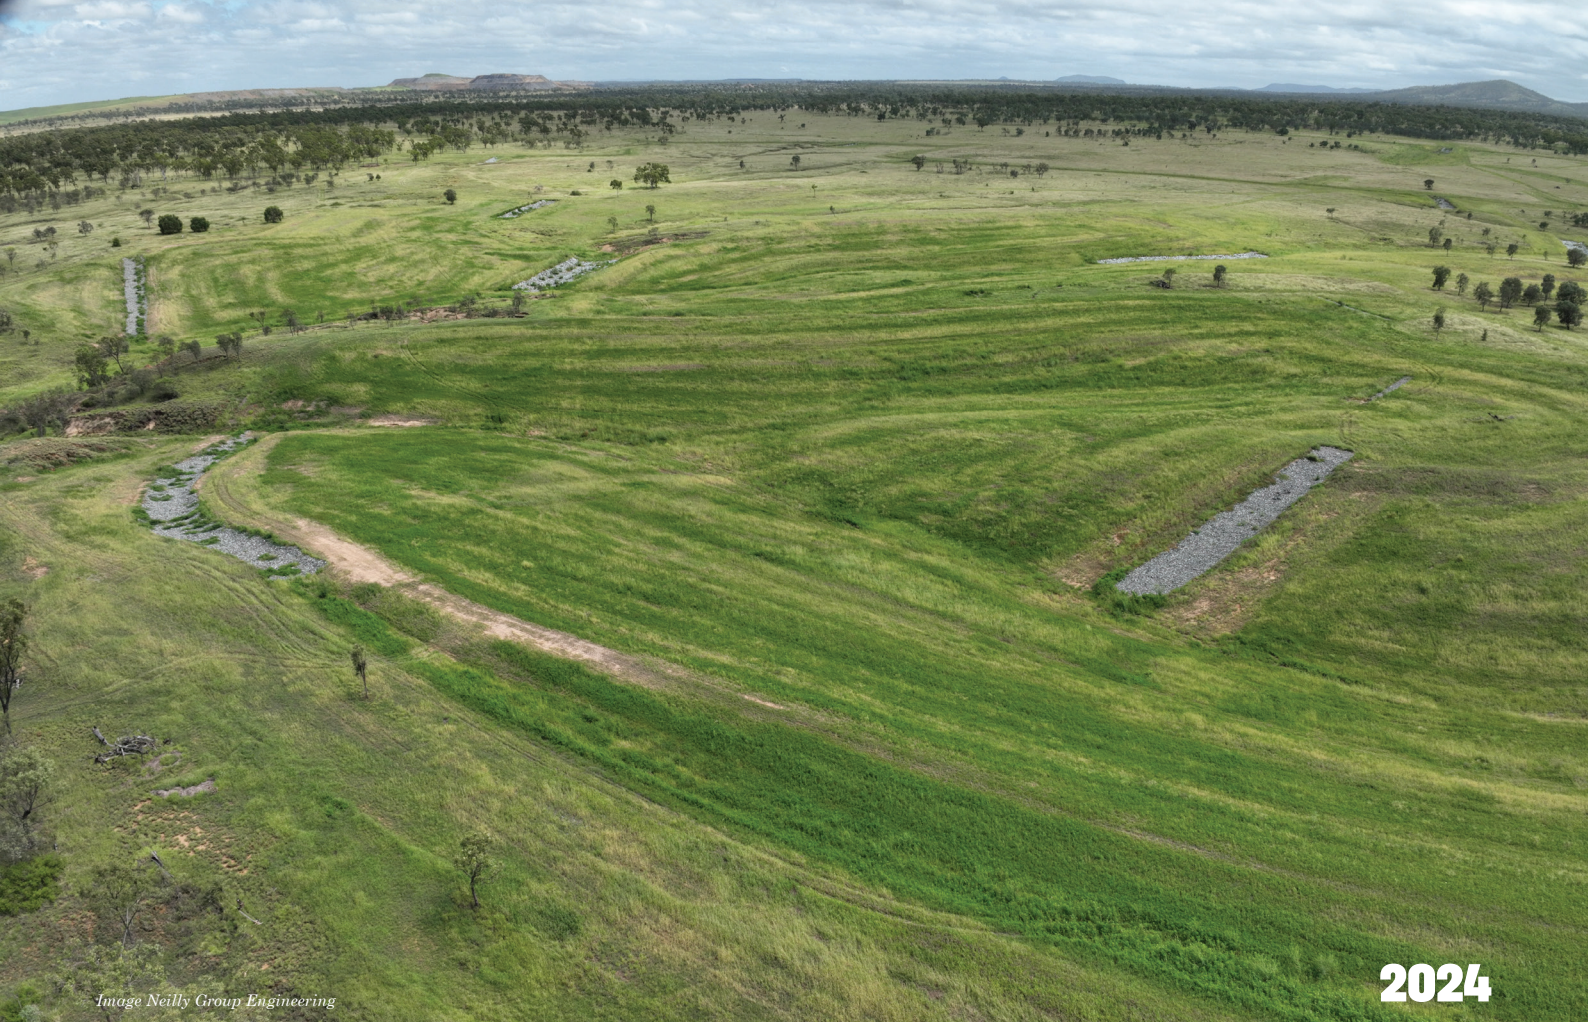
**2024**

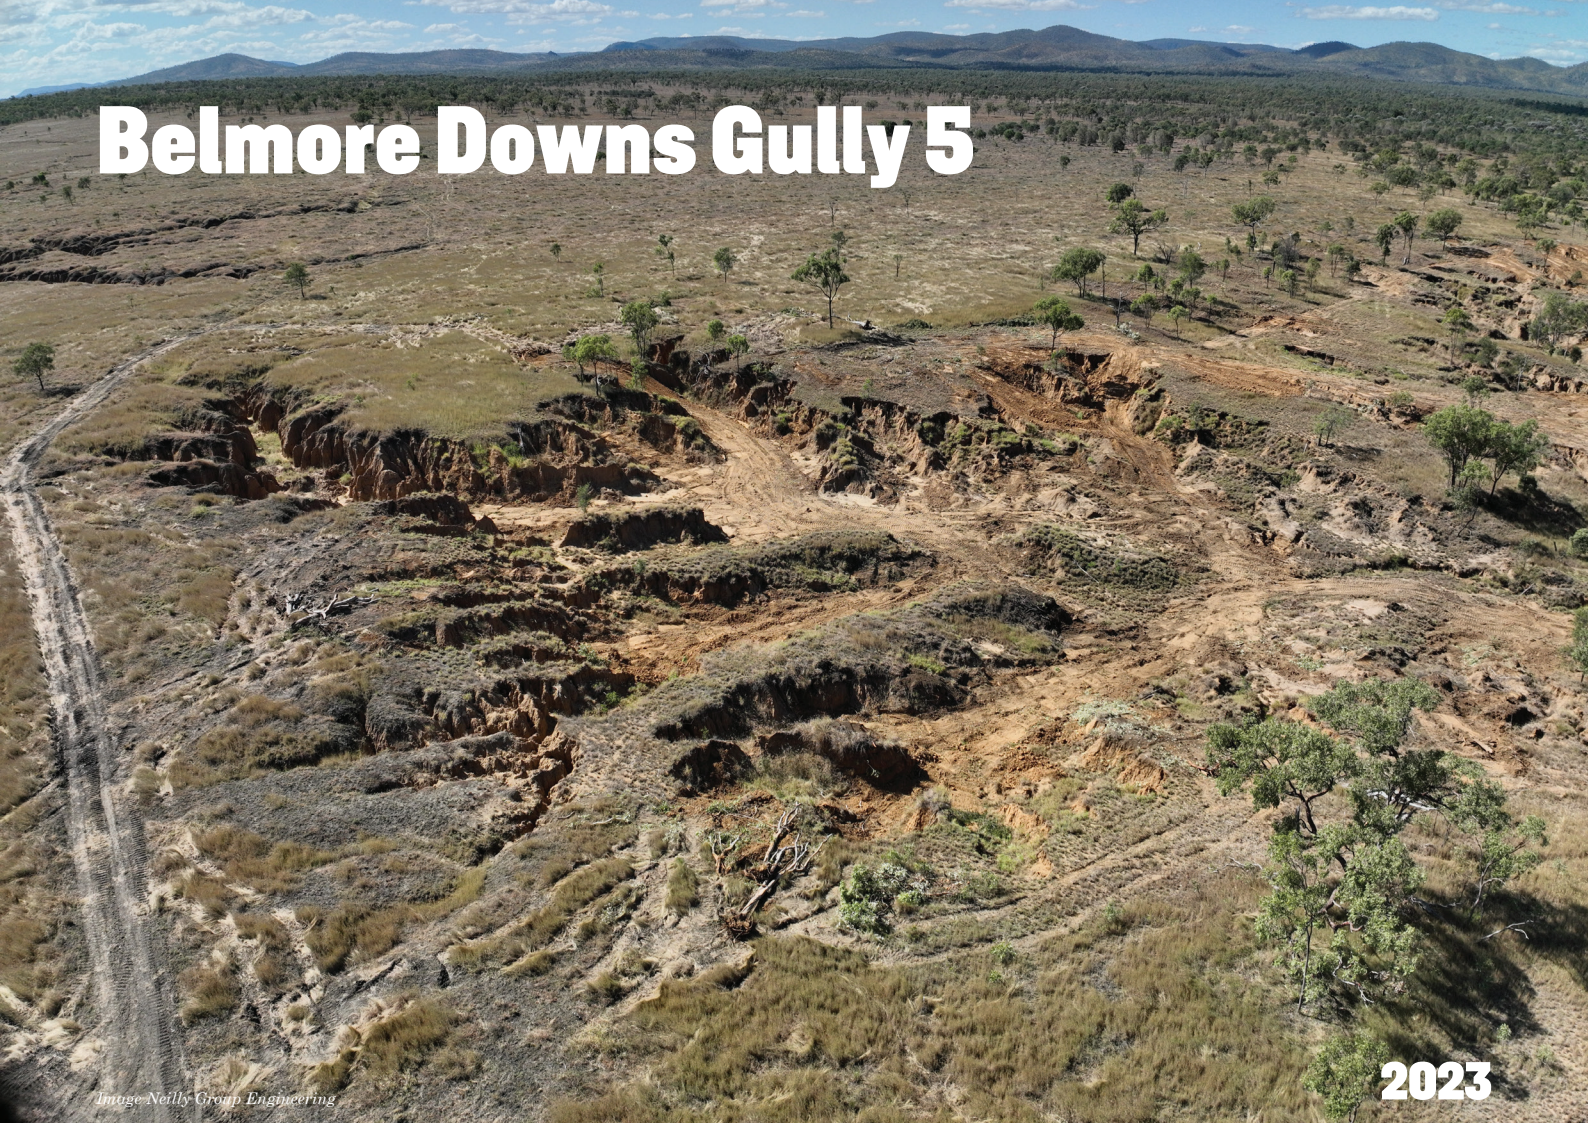
# Belmore Downs Gully 5

**2023**

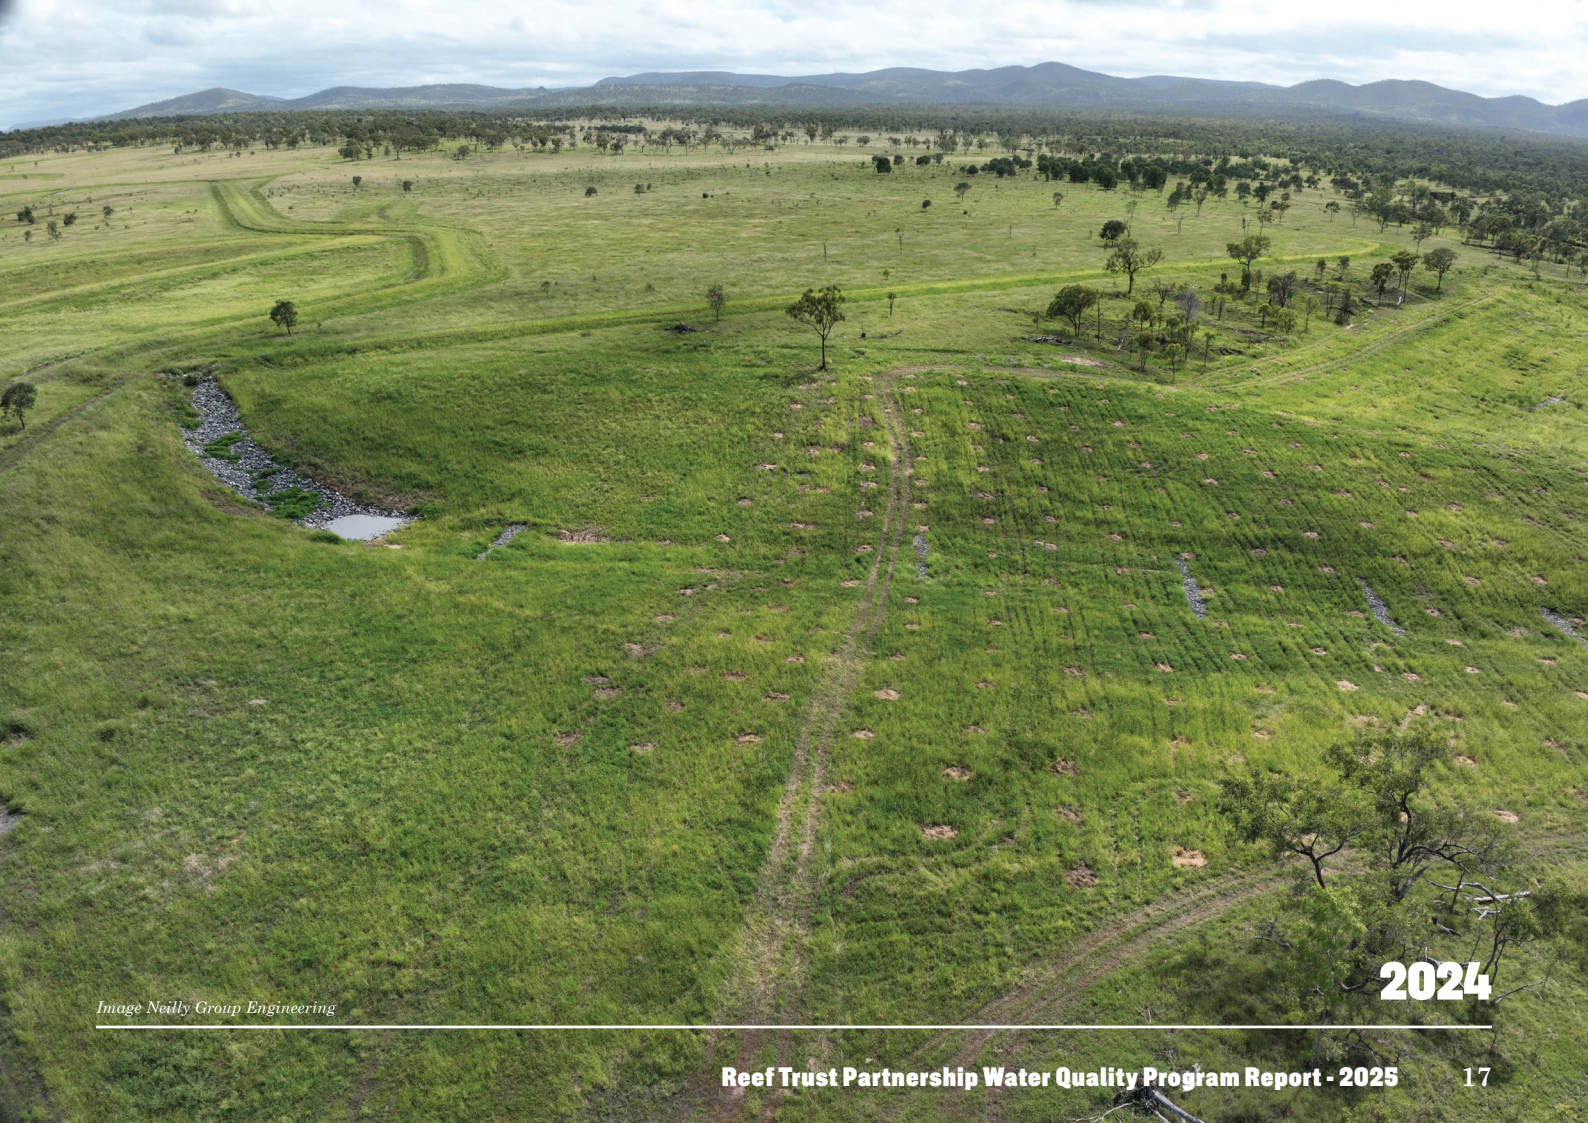
**2024**

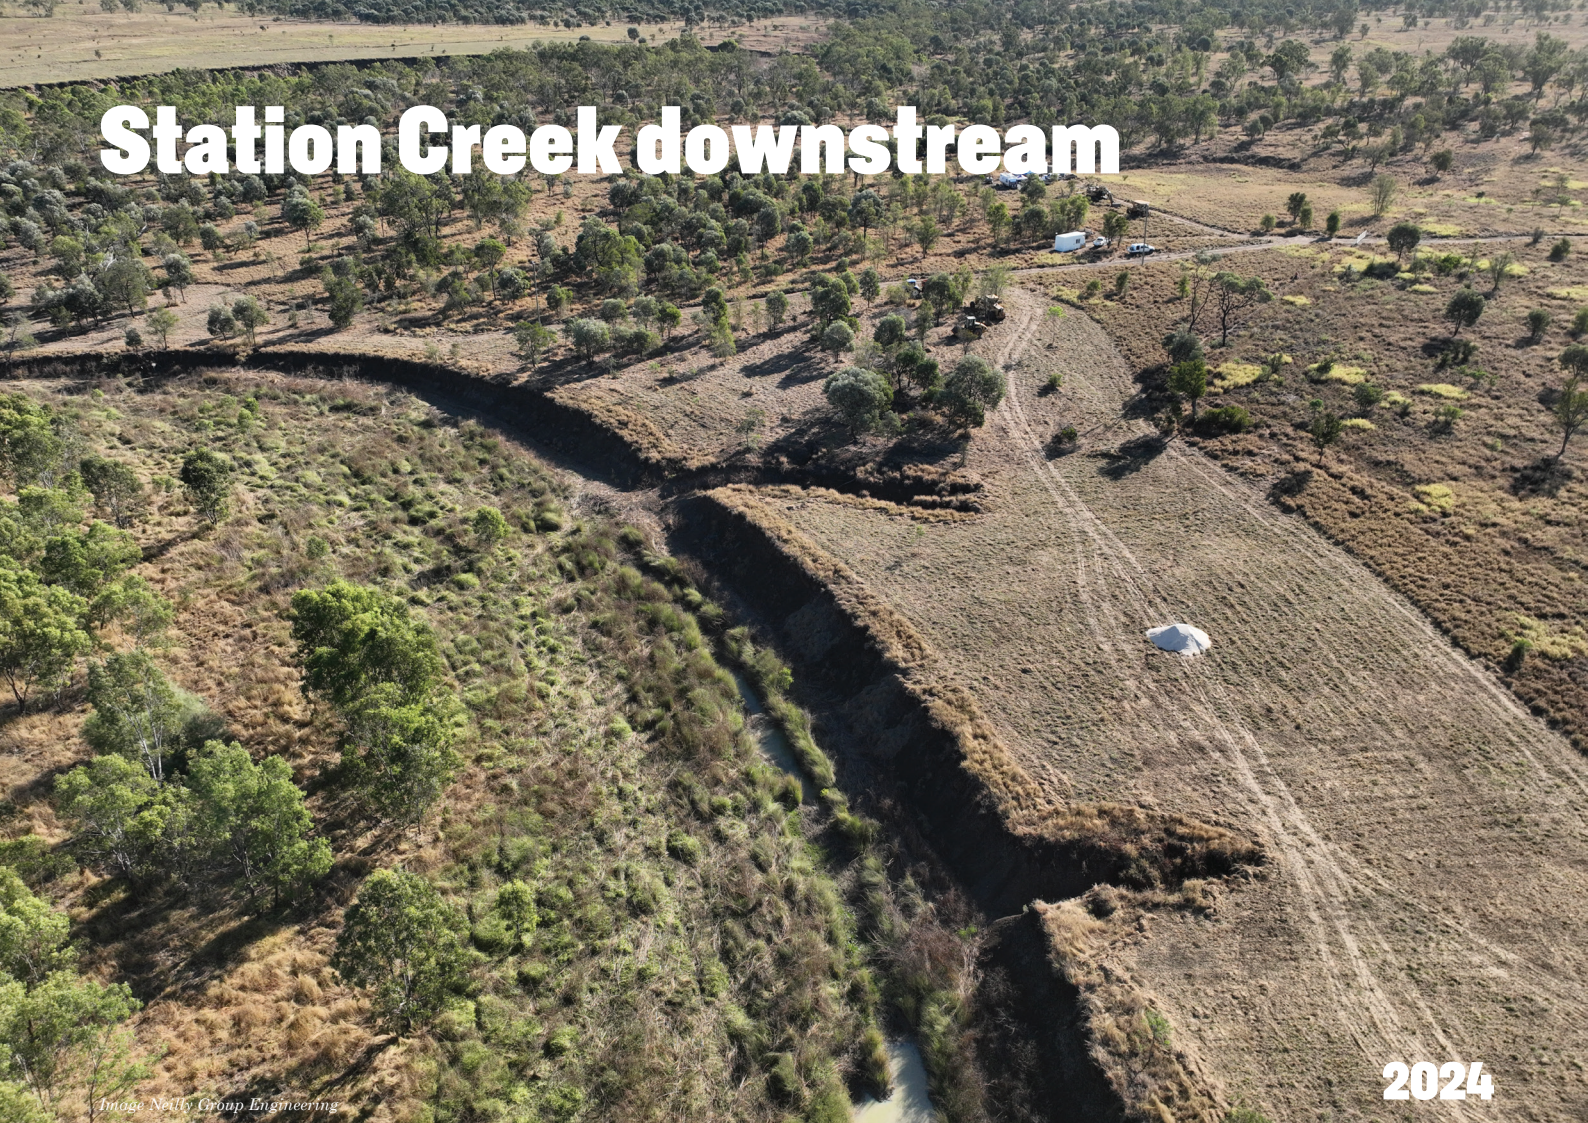
# Station Creek downstream

**2024**

Vertical banks were battered to a stable grade and rock chute batter drains and bunds installed to manage the entry of overland flows through multiple existing gullies. Pile fields were installed to slow down water and trap sediment, and protect and repair damaged riverbanks while revegetation occurs. Over 1900 timber piles were sourced from local contractors, acquired from State forests.

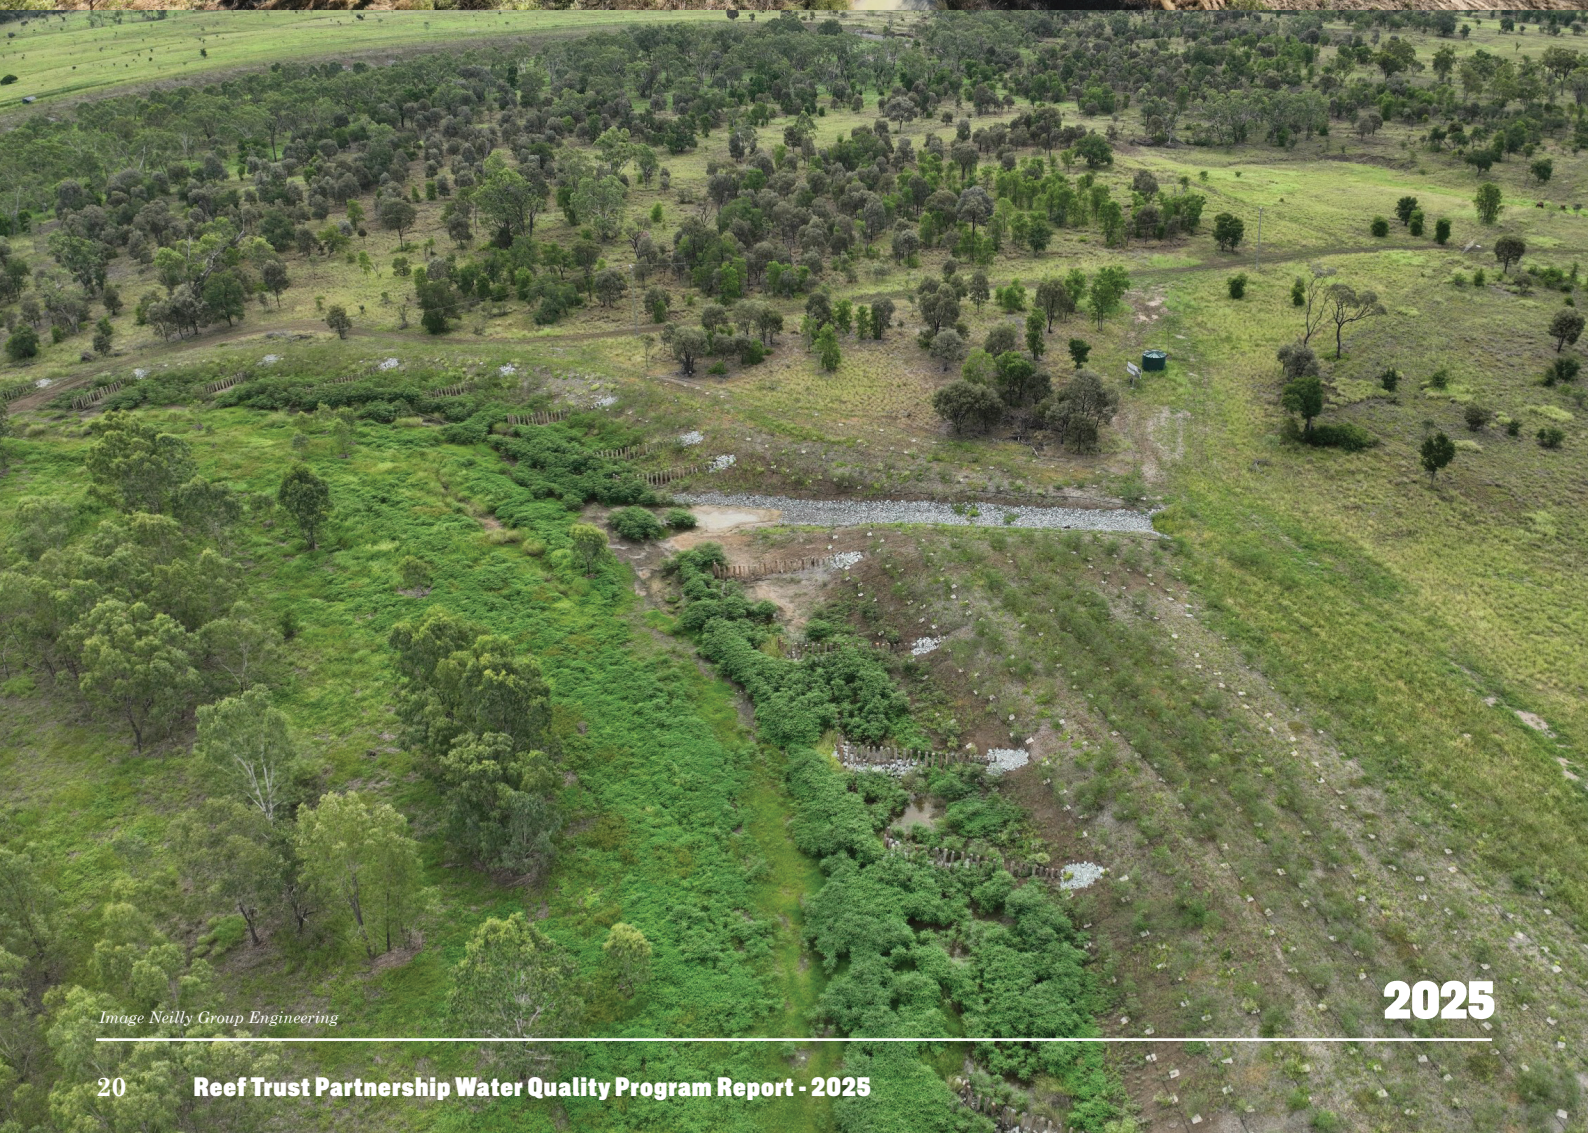
**2025**
