Reef Trust Partnership Water Quality

EASTERN CAPE YORK WATER QUALITY PROGRAM

Impact Report

August 2025

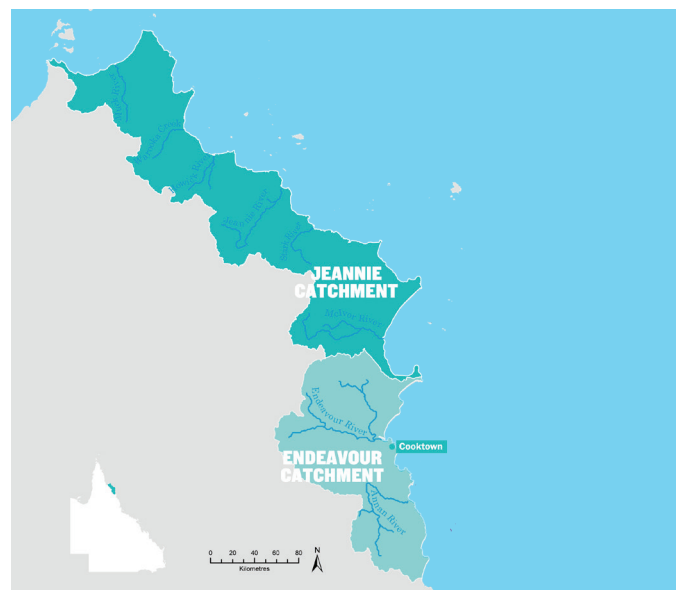
Figure 3. Map of the Jeannie and Endeavour priority catchments in Eastern Cape York.

In the Cape, monsoonal rain and cyclonic activity dominates the wet season which extends from December through to March. The eastern catchments of Cape York (43,000 square kilometres) drain to the Reef (Figure 3) and represent the largest catchment area reporting to the inshore Reef while being located geographically close to the outer Reef.

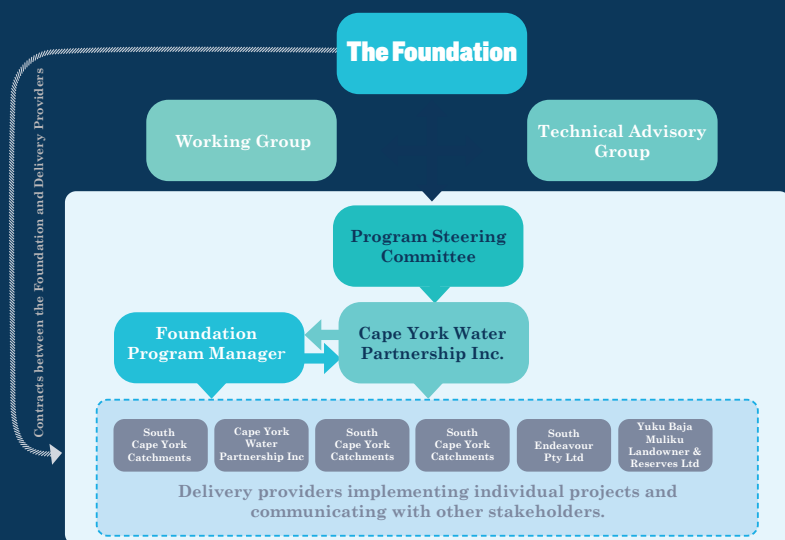
Figure 4. Eastern Cape York Water Quality program governance model

The design of the Eastern Cape York Water Quality program governance model recognised the importance of local leadership, as well as strategic and technical guidance. This model increased transparency of outcomes and ability to manage contractual commitments while providing access to local support to manage risk, coordinate activities, identify synergies, and promote the program to the wider regional audience.

Governance arrangements for the program (Figure 4) ensured the projects delivering on the ground reported directly to the Foundation with support from the regional Program Manager, the Cape York Water Partnership (CYWP). CYWP reported to a regional Steering Committee made up of stakeholders from the CYWP, CSIRO, Bromley Aboriginal Corporation, James Cook University, the Department of Climate Change, Energy, Environment, and the Foundation. The Steering Committee was supported by a Technical Advisory Group and the Water Quality Working Group, which provided technical and strategic advice across the whole of the Water Quality Program.

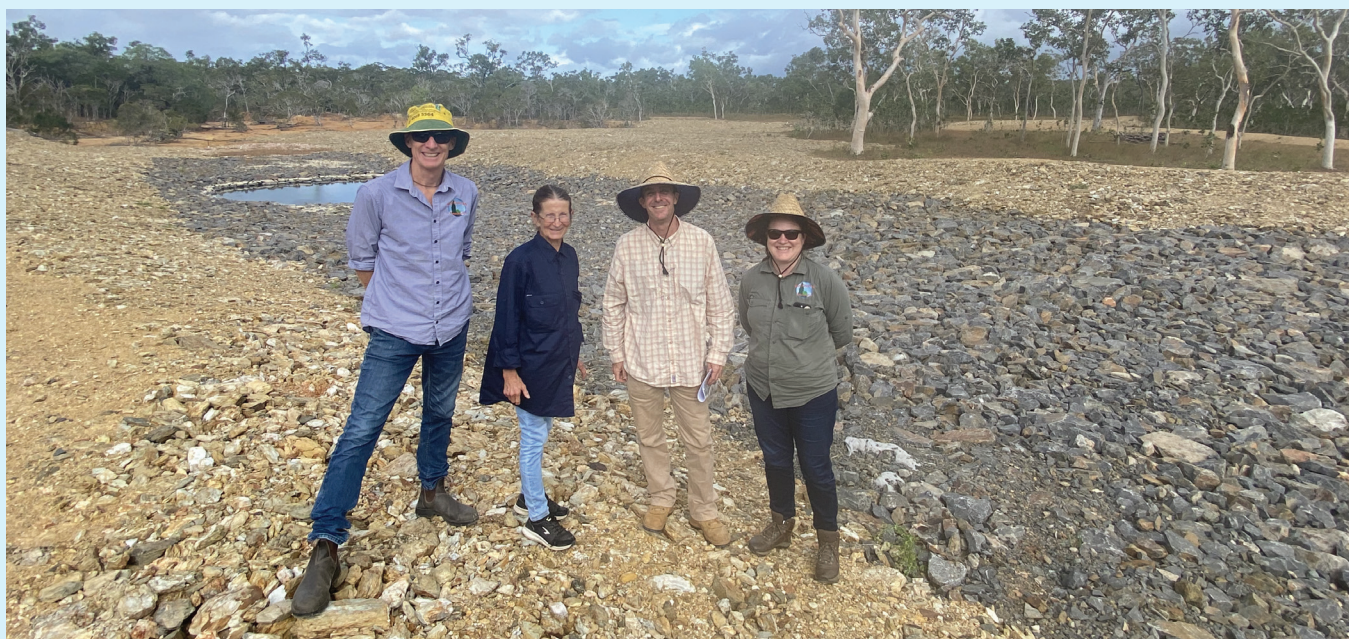
South Cape York Catchments undertook erosion control trials in collaboration with Cook Shire Council. Image SCYC

The trials conducted in the Annan catchment along Oakey Creek Road demonstrated the erosion mitigation benefits of implementing alternative treatment measures

rather than standard bare earth grading of the drains and batters. Measurements taken before and after a wet season indicated that the alternative treatments reduced fine sediment volumes transported to the Reef by between 14% and 72% when compared to the control (business-as-usual practices). Importantly, a [Cost Benefit Analysis](#) conducted on these trials showed a positive trend over the medium to longer term period against the control.
